Report on the Partial Grid Disturbances in the Northern Regional Electricity Grid on 02nd January 2010

Submitted to the Honourable
Central Electricity Regulatory Commission

The Report is in compliance to the CERC's order dated 14th January 2010 in Petition number 2/2010 in the matter of grid disturbances in the Northern Region on 02nd January 2010

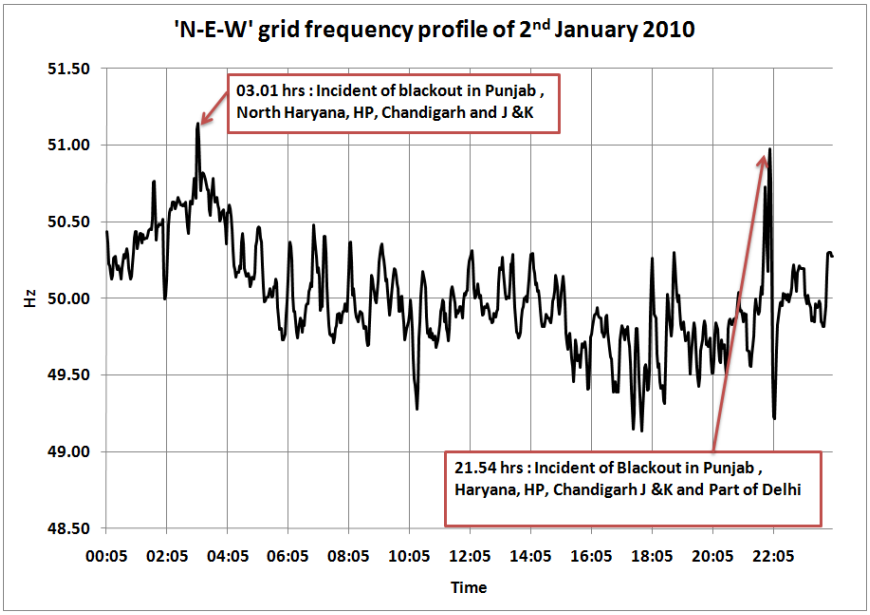
Figure 1: Frequency Profile of 02nd Jan-10

It would be seen from the frequency profile below that the frequency remained above 50.5 Hz between 0200-0300 hours. This was primarily on account of the disruption in load fed from several 220 kV substations on account of tripping of 220 kV lines. Even then the generating stations in the entire NEW grid could have back down generation in a pro-active manner (barring the generators in the North West part) as per the frequency linked dispatch guidelines and ensure that the frequency does not go much beyond 50 Hz. This action was obviously inadequate.

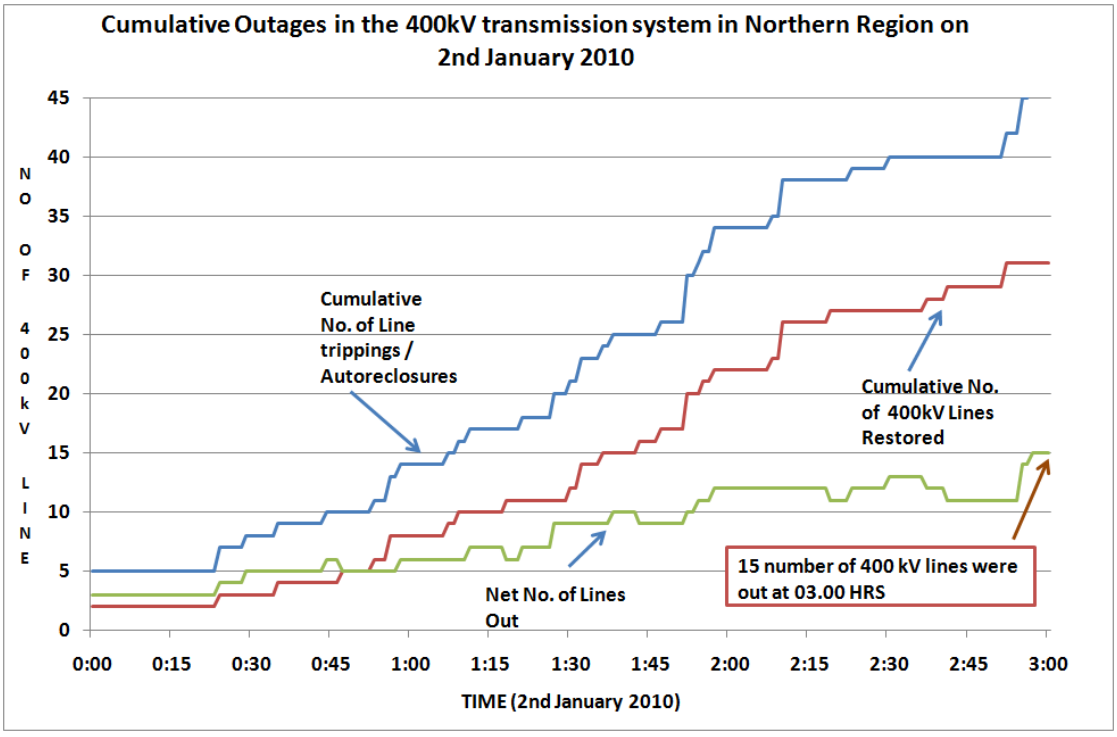
Figure 2: Cumulative outage in the 400 kV transmission system

In respect of 400 kV system above, it would be seen that efforts were made to restore the lines immediately after the trippings took place. However in respect of the 220 kV system, the cumulative net number of lines at any point of time which were out kept mounting suggesting that the Mean Time To Restore (MTTR) was quite high.

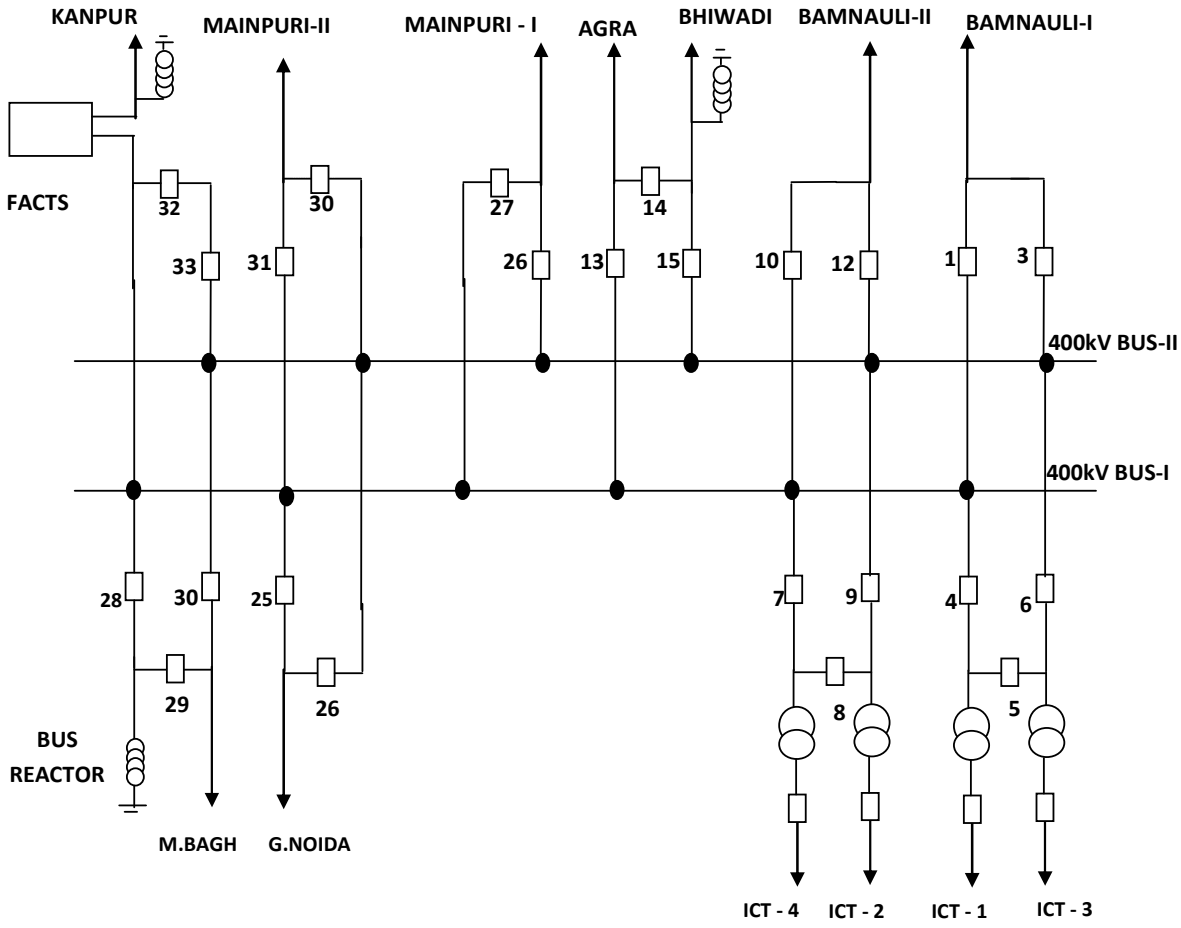
Figure 4: Single Line Diagram (SLD) of 400 kV Ballabgarh substation

the Local Breaker Backup (LBB) of this breaker and isolation of 400 kV Bus-1 at Ballabgarh. (Please refer Single Line diagram of Ballabgarh substation for ease of understanding). No proper DR or EL output is available from 400/220 kV Bamnauli substation for this tripping.

As the 400 kV Ballabgarh (PG) substation has a breaker and half switching scheme and all tie breakers were in service, this outage of 400 kV Bus-1 through tripping of all breakers connected to this bus did not lead to any further element outage. The other elements continued to remain connected with the grid through the tie breaker or 400 kV Bus-2 breakers.

The Numerical relay and Event Logger output of this line at Ballabgarh end is enclosed at Exhibit-3/II. It is seen that the fault has been cleared within 250 ms (corresponding to distance protection operation plus LBB timer) after isolation of 400 kV Bus-1 as explained above. The Event Logger also shows that the R-pole of the 400 kV Bus-1 breaker for Bamnauli-2 feeder has opened three seconds later on pole discrepancy. It was this stuck breaker that caused LBB protection to operate. Delhi

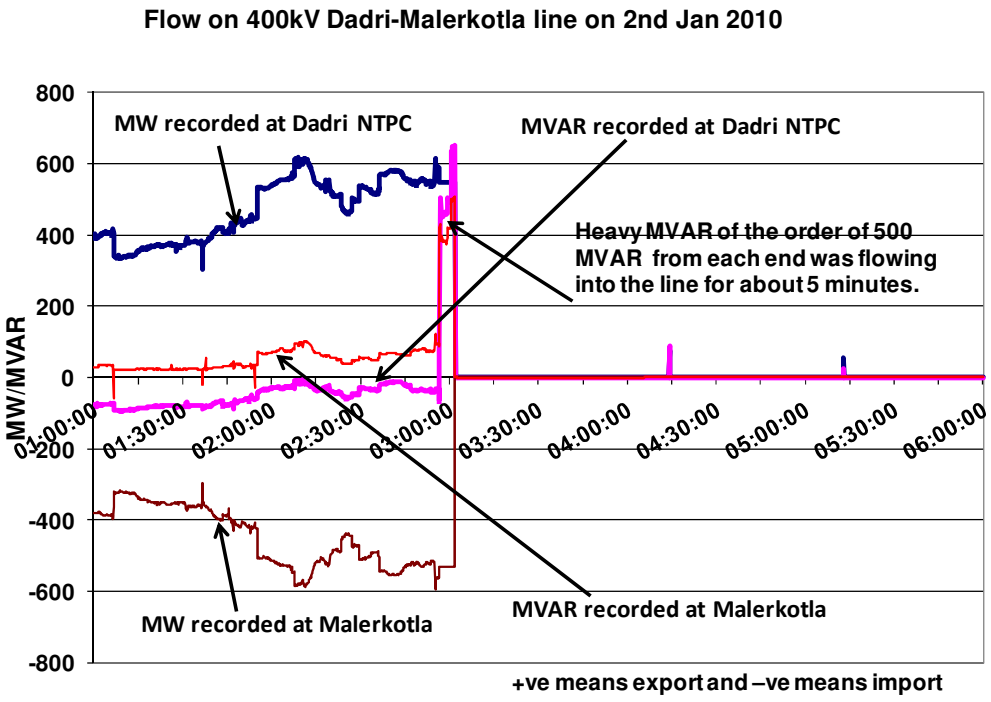
Figure 5: MW and MVAR flow on 400 kV Dadri-Malerkotla line on 2nd January 2010

While the reactive power flows on transmission lines are not monitored very closely, as the same is not very significant under normal line loading conditions, the same assumes great importance when the transmission network is loaded heavily. After the incident, the Historical Data Replay at NRLDC revealed high MVAR drawn by the 400 kV Dadri-Malerkotla line from both ends between 0256 to 0301 hours. This is illustrated in **Figure 5**.

Initially this seemed to suggest an uncleared fault on the line (as there was an incident of an uncleared fault on 400 kV Dadri-Panipat-1 for close to 2 minutes 50 seconds on 22nd Sep 2008). Subsequently, through off-line simulation, it was seen that the high reactive power drawn by the line would occur at high level of MW loadings. In this case, while the SCADA data shows that the MW values had frozen at around 550 MW, the actual power flow on 400 kV Dadri-Malerkotla line would have been much above 1000 MW. The reactive power drawn by the line vis-à-vis line current is illustrate graphically below in **Figure 6**.

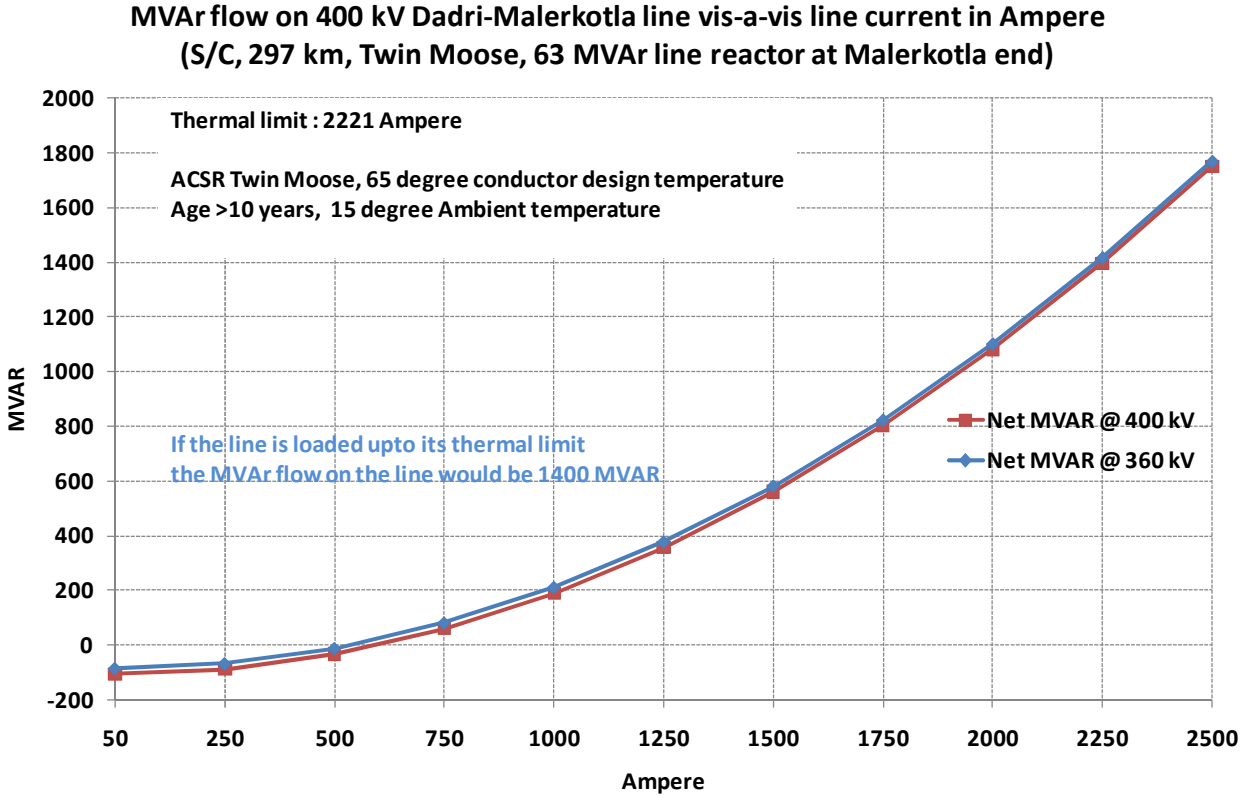
Figure 6: MVAR losses on 400 kV Dadri-Malerkotla line with increase in loading

The Historical Data Recording (HDR) also indicates that the flow on 220 kV Hissar-Sangrur D/C initially increased from 220 MW to 380 MW and thereafter to 690 MW. The voltage at Sangrur and Hissar also dipped by 25 kV-30 kV on account of approx. 360 MVAR reactive power losses on this line.

The reactive power requirements under such a situation would have to be met from the generators nearby such as Dadri NTPC, Lehra Mohabat TPS, GNDTP, Yamuna Nagar TPS, Chamera-I and Jhakri HPS. Outage of the generating units at Ropar TPS and Panipat TPS Stage-II in this incident caused a shortfall in dynamic reactive reserves available leading to a higher voltage drop. Under Voltage Load Shedding (UVLS) assumes great importance in such situations. Absence of this defense plan can lead to a situation of voltage collapse.

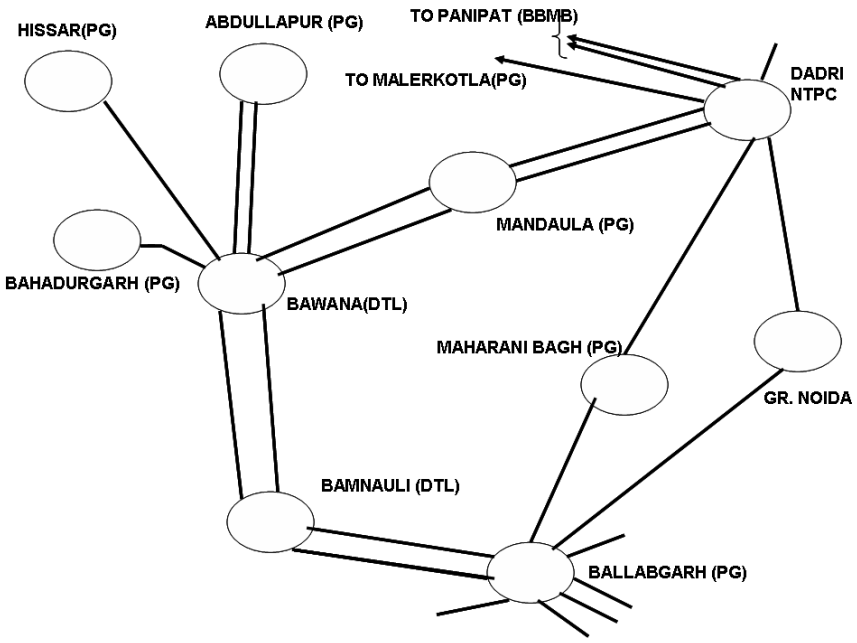
Figure 7: Sketch of 400 kV Delhi ring main system

For the sake of understanding please refer **Figure 7** and **Figure 8** below.

4.2.1 Tripping of 400 KV Bamnauli-Ballabhgarh Ckt.-2

The 400 kV Bamnauli-Ballabgarh D/C line has micromho distance protection at Bamnauli end for both Main-I (permissive underreach) and Main-II (blocking). These relays do not have any facility for recording. The DR outputs from Bamnauli submitted by DTL are not meaningful as the date and time is not in order. DTL has however installed a numerical relay REL 511 for the purpose of disturbance recording and not for protection on both the Ballabgarh lines at Bamnauli. Two outputs from these relays installed on Ballabgarh-2 feeder at Bamnauli triggered during this period of sustained fault are enclosed at Exhibit-4/VIII. The timings indicated in these outputs are not synchronized with GPS. It is seen from these outputs that there is a current of the order of 6 kA rms on the R-phase and voltage in R-phase is depressed. This indicates that the fault is being fed on this circuit. The following questions arise out of this fact. (Please refer to the Delhi ring main sketch at **Figure 7** above for ease of understanding)

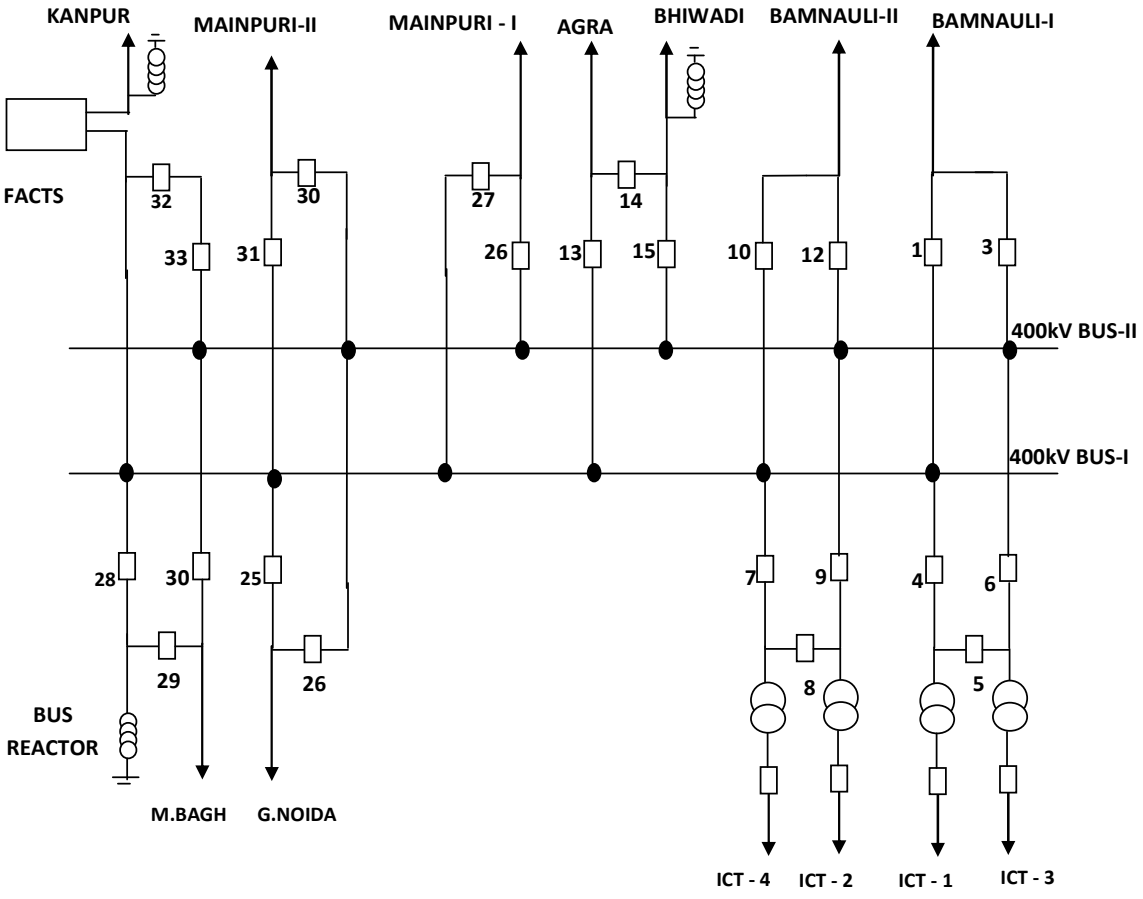
Figure 8: Single Line Diagram (SLD) of 400 kV Ballabgarh substation

The first event recorded in the Sequence of Events at NRLDC was the tripping of 400 kV Bamnauli-Ballabgarh-2 at 21:44:09:255 (at Bamnauli end) and at 21:44:09:288 at Ballabagarh end. The Numerical Relay output at Ballabgarh end of this line indicates a R-phase to ground fault on the line. (Exhibit-4/I). Although Main-1 protection operates at this end, the fault is seen for a period of 300 msec (15 cycles). It is seen from the NRLDC SOE (Annexe-4/I) that the fault has apparently cleared from Ballabgarh end only after operation of the Local Breaker Backup (LBB) of 400 kV Bus-1. This has happened as the R-pole of 400 kV Bus-1 breaker of Bamnauli-2 circuit at Ballabgarh end has failed to open after operation of distance protection. Although the fault was cleared in 300 msec due to 400 kV Bus-1 trip, the Numerical Relay output shows that the R-pole of this breaker has opened 3 seconds after the occurrence of fault on pole discrepancy.

Thus the fault is cleared through three phase trip at Ballabgarh end at 21:44:09:530 (400 kV Bus-1 LBB) and at 21:44:09:591 at Bamnauli end (only one breaker viz. 352

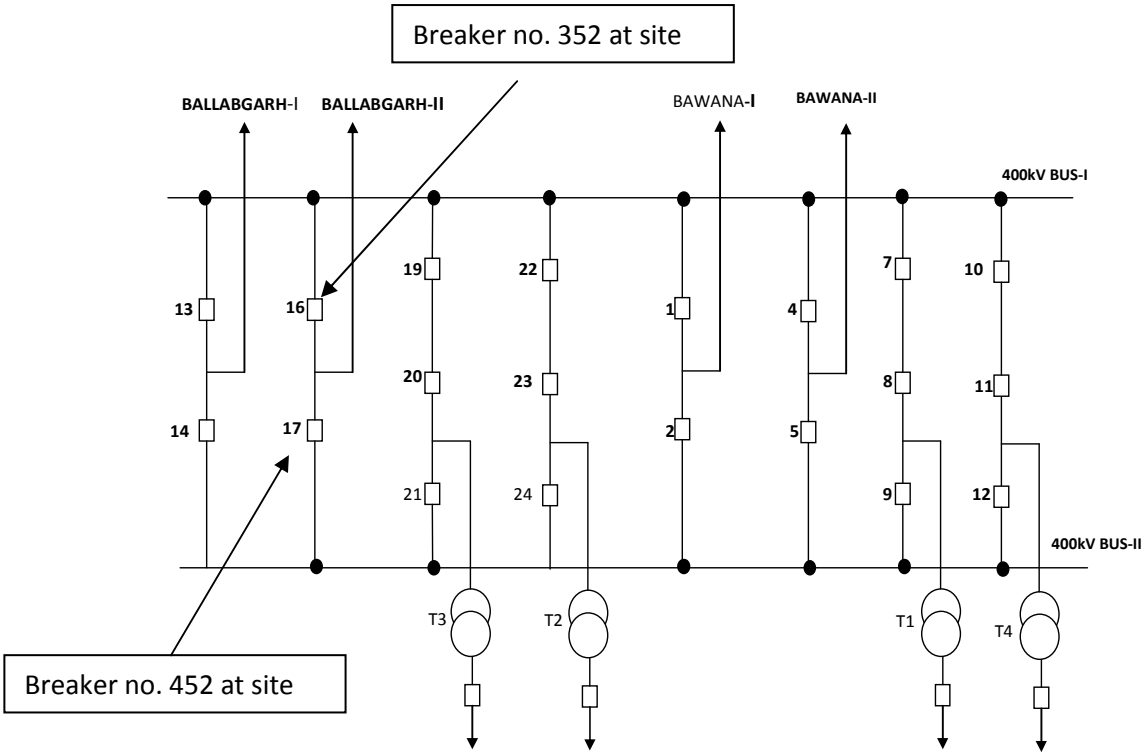
Figure 10: Single Line Diagram (SLD) of 400 kV Bamnauli substation as per NRLDC SCADA

It is observed from the SoE recorded at NRLDC that breaker no. 452 (1752 as per NRLDC SCADA) had been put off since 0956 hours on the morning of 2nd January 2010. Therefore, at the time of the incident only breaker no. 352 (1652 as per NRLDC SCADA) was in service. This breaker tripped at 21:44:09:591 as per the SoE and has not auto-reclosed.

This and the sustained fault thereafter on 400 kV Bamnauli-Ballabgarh-2 being fed from Bamnauli could be possible if R-pole of the breaker No. 452 had auto-reclosed on to the fault. If the bus isolators were in closed condition, the fault would start getting fed from 400 kV Bamnauli. Since there is no proper Event Logger at 400 kV Bamnauli substation, this aspect cannot be additionally corroborated.

In the breaker and a half switching scheme or the double bus double breaker scheme such as above, in case any breaker has to be kept off due to any problem, the auto-reclosure feature should be kept in 'non-auto' mode to avoid any reclosure. This has to be toggled manually. Further, the isolators on both sides of a breaker are kept open in case the breaker has to be attended to. However in case of any oversight such as not keeping the switch in 'non-auto' mode and keeping the isolators ON, there could be a mishap such as above.

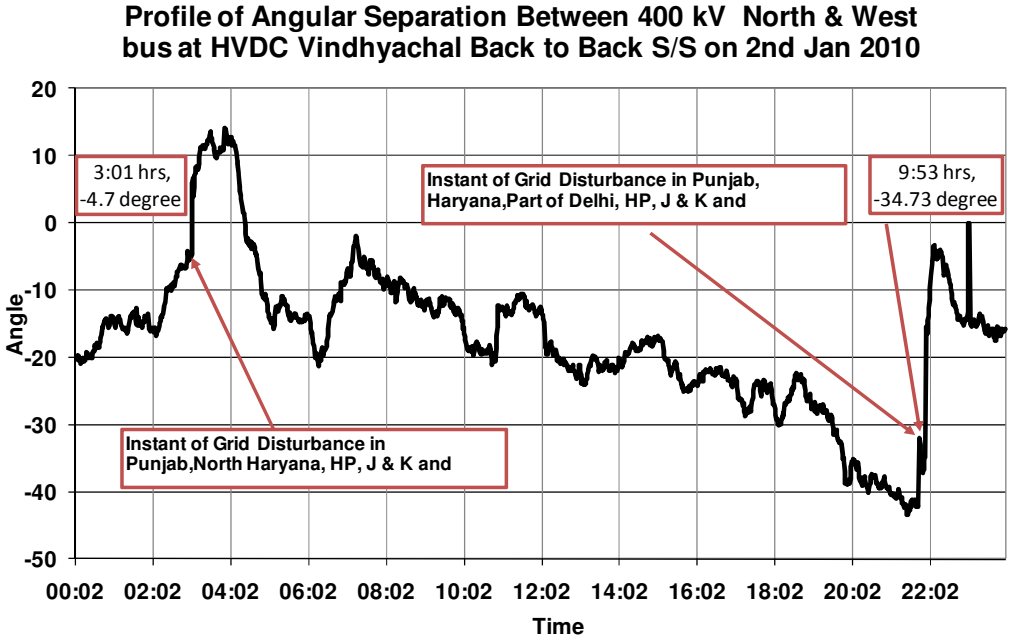
Figure 11: Angular separation between North & West bus at Vindhyachal HVDC back to back

The angular separation between the North and West 400 kV bus at Vindhyachal during the entire day is shown in **Figure 11** below which shows a sharp spike in the angular difference at the two instances of separation. Positive sign of angle indicates that North bus is leading while negative sign shows that West bus is leading. Visualization of angular separation between buses would also be made possible in Northern region through the synchrophasor technology. As part of adopting this technology, NRLDC is already going ahead with a pilot project involving four (4) Phasor Measurement Units (PMUs) being installed at Vindhyachal HVDC back to back station, Kanpur, HVDC Dadri and 400 kV Moga substations. This would provide a parallel means of real time monitoring independent of the Energy Management System (EMS).

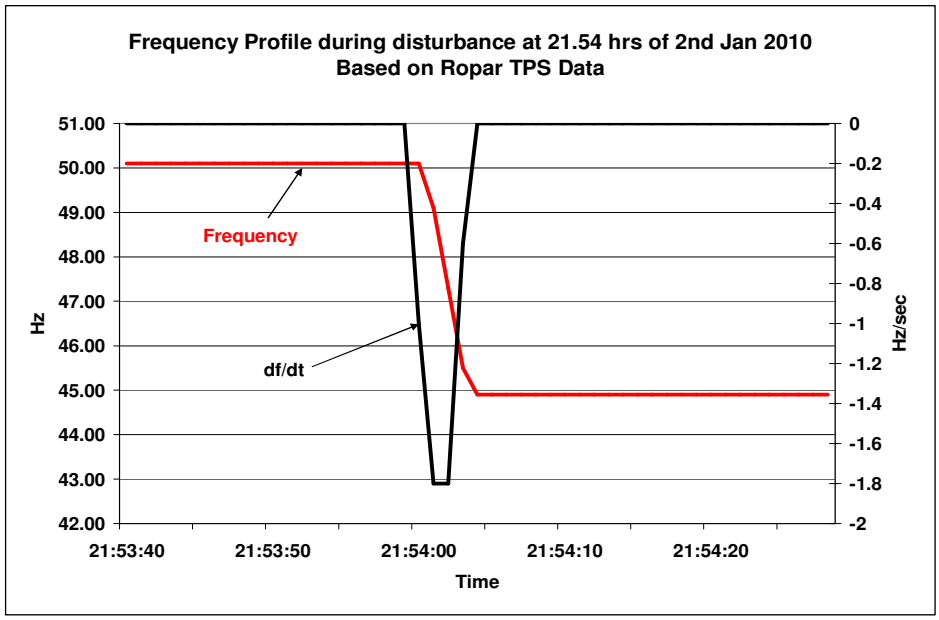
Figure-12: Frequency and rate of change of frequency plot

One second interval SCADA data of the Ropar TPS indicates (pl refer Ropar Historical Tabular Trend data at Annexe 5-II) that frequency touched the minimum level of 45.5 Hz at the instance of blackout at 21.54 hrs of 2nd Jan 2010 and the rate of change of frequency (df/dt) was of the order of 1.8 Hz/sec. The frequency and df/dt plots for the 2154 hours incident are shown in **Figure 12** and the details of load relief are given in Table below.

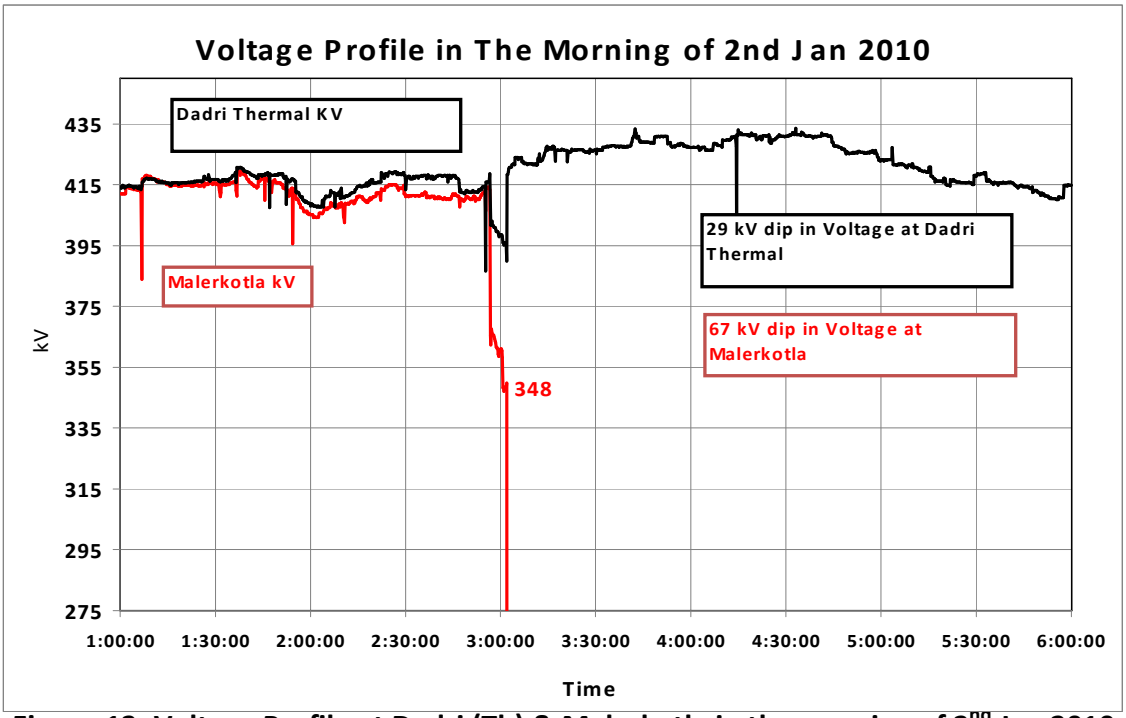
Figure-13: Voltage Profile at Dadri (Th) & Malerkotla in the morning of 2nd Jan 2010

Plot of voltage profile at Dadri (Th), Malerkotla, Srinagar and Kishenpur during the grid disturbance at 03.01 hrs are shown in Figure 13 and 14. It has been observed that dip in voltage at Dadri (Th) was of the order of 30 kV and at Malerkotla was of the order of 67 kV. The voltages at Kishenpur and Srinagar were dipped by 30 kV and at Hisar-Sangrur dipped by 25 to 30 kV. Such a low voltage profile persisted for about 5 minutes.
